Annual Report NPDES Municipal Separate Storm Sewer System Permit

Published by the Montgomery County Department of Environmental Protection
for the Maryland Department of the Environment

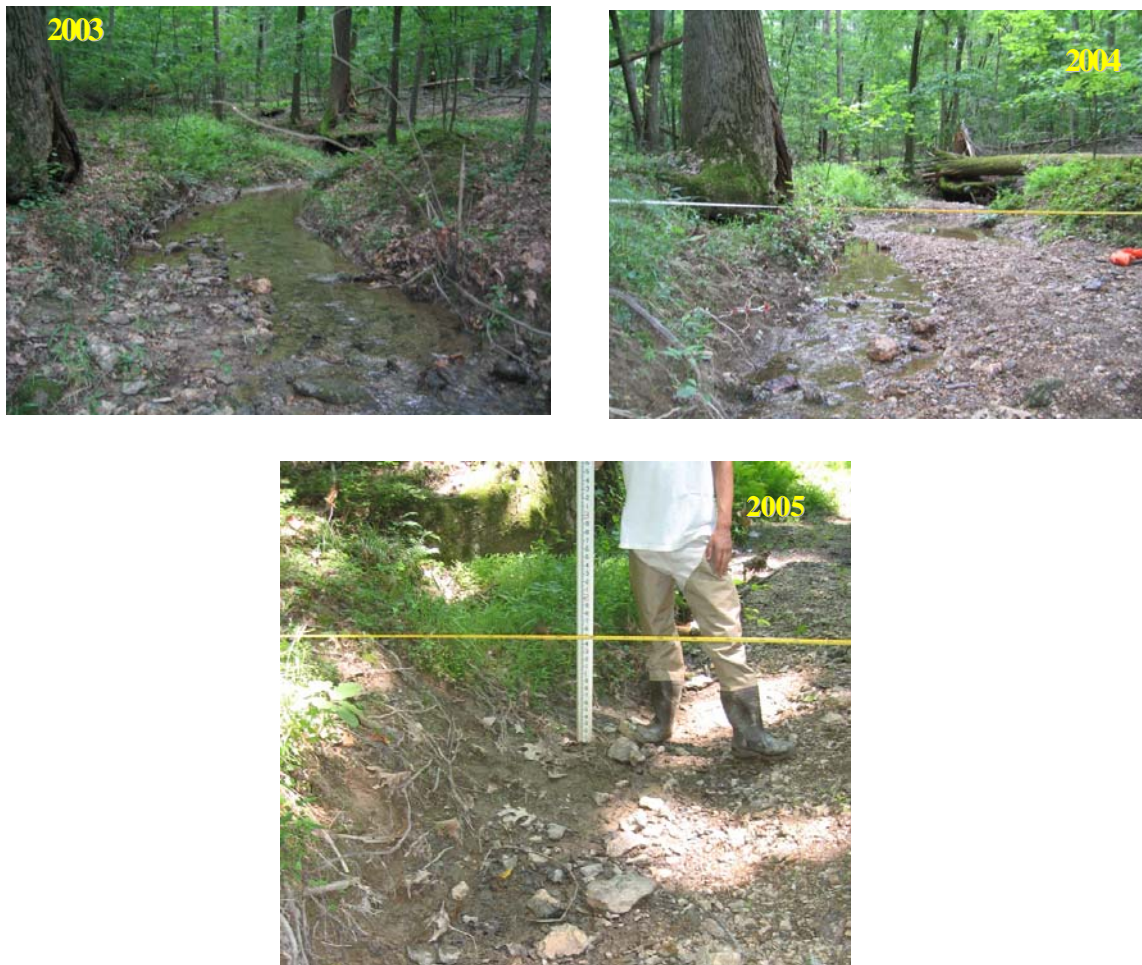
***Figure III-D11. Soper's Branch (LBSB101) Control Area 2 Cross Section 1.
Facing Upstream. 2003-2005.***

As seen in the previous report, photo documentation can be extremely helpful in examining stream changes. In 2005, the water level in the streams were extremely low during most of the monitoring. In fact, Area 2 of the control area was completely dry as shown in Figure III-D11.

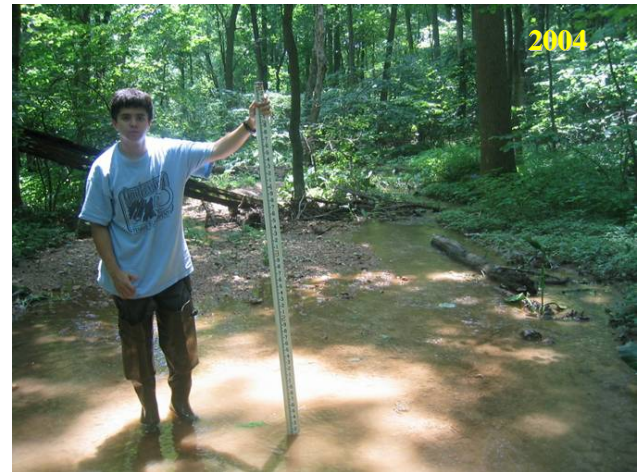
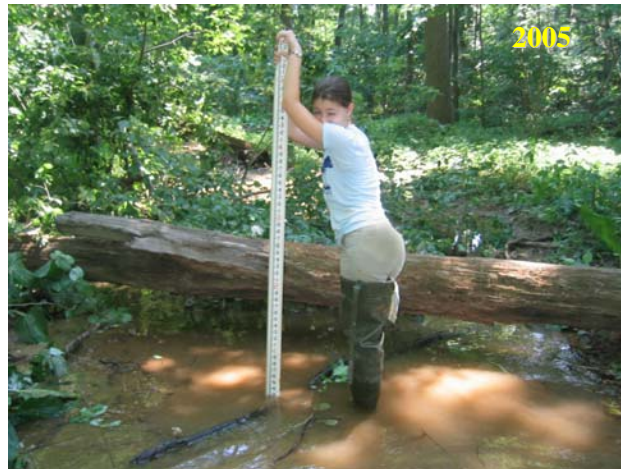
*Figure III-D12. Little Seneca (LSLS104) Test Area 4 Cross Section 1.
Facing Downstream. 2002-2005.*

In test area 4, the stream cross-section has not changed drastically. As shown in Figure III-D12., a tree was found downed in the stream during 2005, just downstream of cross section 1. The blockage does not affect baseflow, but may have an impact during a flood event.

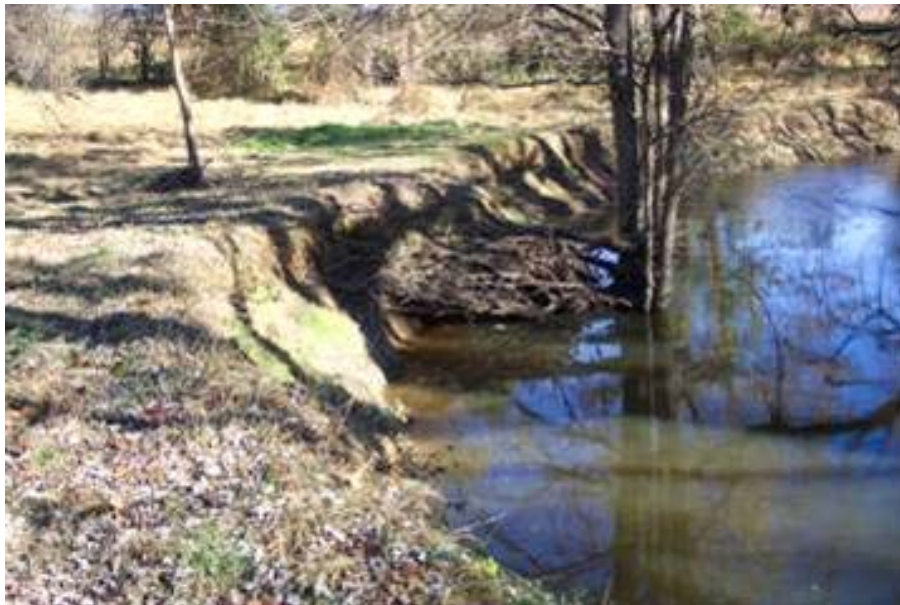
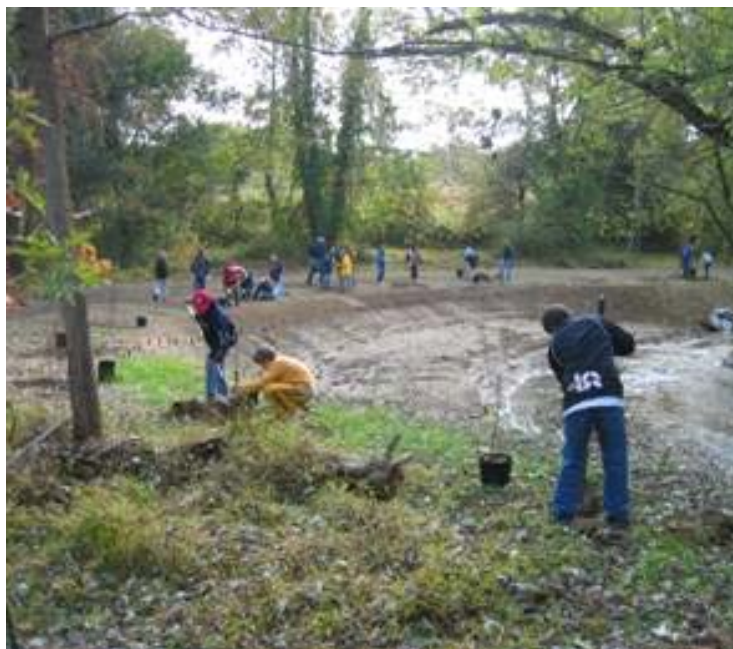
Figure III-E2. Before and during Volunteers in Planting restoration along Lower Hawlings River. Fall 2005.

At the Lower Hawlings Project, about 200 native trees were planted along part of the 2,800 ft restored reach. Figure III-E2 shows before and during planting photographs of one part of that reach. The TU has committed to monitoring and maintaining the buffer planting over the next several years to control invasive plant overgrowth. The DEP provided technical guidance and also acted as a liaison with three local high schools to solicit additional volunteers for the planting phase.
